U.S. Department
of Transportation
**Federal Highway
Administration**

In Reply Refer To:
HSST-1/ WZ - 381

- Type III Barricade with X-Tube upright and footing

Pexco T3B Barricade with X-Tube Upright and Angle Iron Feet

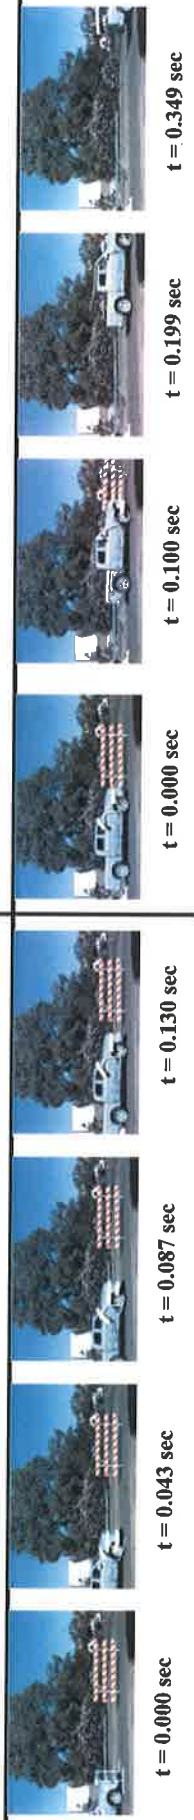
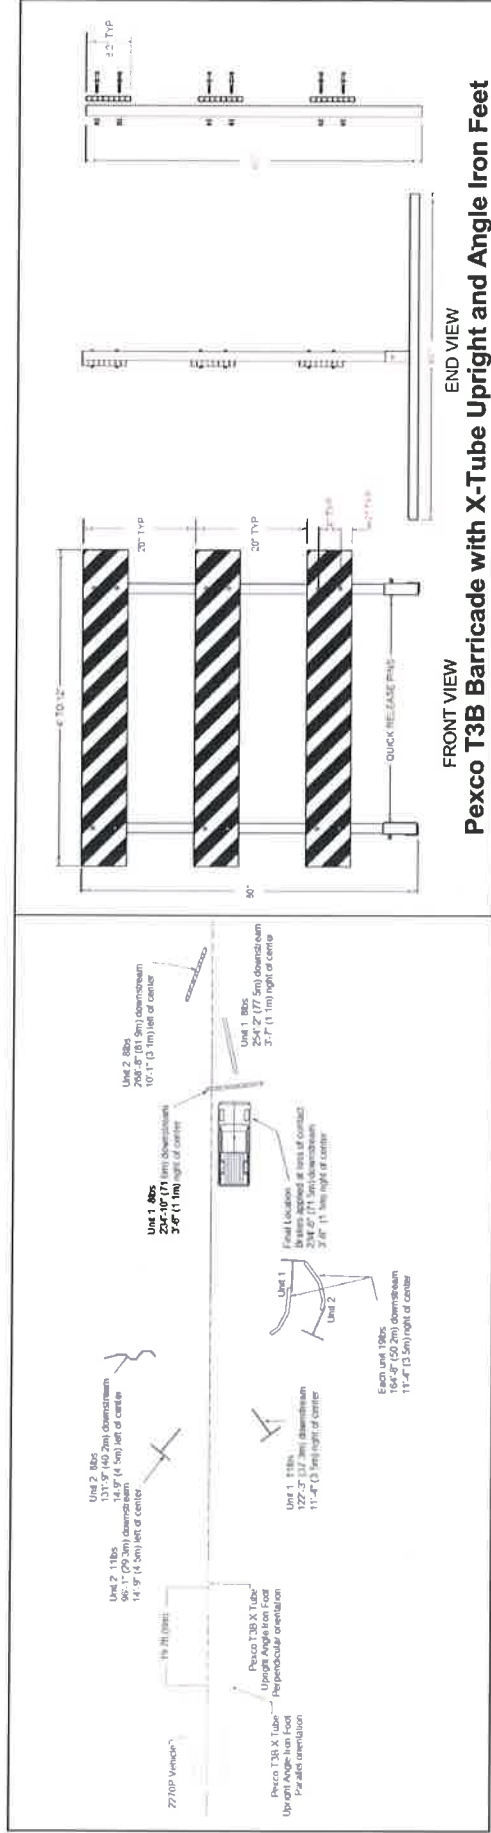
Normal (0 deg) Orientation

Perpendicular (90 deg) Orientation

General Information		Test Vehicle		Vehicle Damage	
Test Agency.....	E-TECH Testing Services	Type.....	Production Model	Exterior	
Test Designation.....	MASH Test 3-72	Designation.....	2270P	VDS.....	FC-0 (negligible)
Test No.....	81-0461-002	Model.....	2011 Dodge Ram 1500	CDC.....	12FCLW0 (negligible)
Date.....	6/28/2017	Curb.....	2285.0 kg	Occupant Compartment Deformation	
		Test Inertial.....	2275.0 kg	Windsshield.....	N/A
		Dummy.....	N/A	All other areas.....	N/A
		Gross Static.....	2275.0 kg		
Test Article					
Type.....	Pexco				
	12 m wide T3B Barricade with				
	X-Tube Upright and Angle Iron Feet				
	Work-Zone Traffic Control Device				
Dimensions.....	1.52 m OA Height x 3.66 m Wide				
Installation Details.....	Three horizontal panels measuring 1.52 m, 1.02 m and 0.51 m high (Top of Panel to Grade)				
Material and Key and Elements	19.5 kg Complete, Steel Legs, RPVC Uprights and (3) 3.66 m wide HDPE Panels with Reflective Sheeting

Foundation Type and Condition	Asphalt, clean and dry

For the 0 deg test article, the 2270P vehicle's front bumper first impacted the lower HDPE panel of the test article and the grill impacted the middle panel. As the uprights began to buckle, one of the angle iron feet contacted the passenger running board under the passenger front door and tore the outer sheet metal skin. There was no additional damage/penetration beyond the outer layer.

The test vehicle sustained negligible damage to the front bumper, hood and roof. The front plastic grill was damaged and slightly displaced. As the legs of the barricade (0 deg orientation only) wrapped around the front end of the vehicle, the leg of the test article temporarily lodged into the vehicle's rocker panel but did not enter the occupant compartment whatsoever. There was no damage to the windshield. The damage to the test vehicle was categorized as FC-0 (negligible) on the Vehicle Damage Index and as 12FCLW0 (negligible) on the Collision Deformation Classification Scale along the principal direction of force. There was negligible deformation to the occupant compartment based upon pre and post-test measurements. The Vehicle Compartment Deformation Index (VCDI) was categorized as AS0000000 as there was no measurable or visual deformation of the occupant compartment.

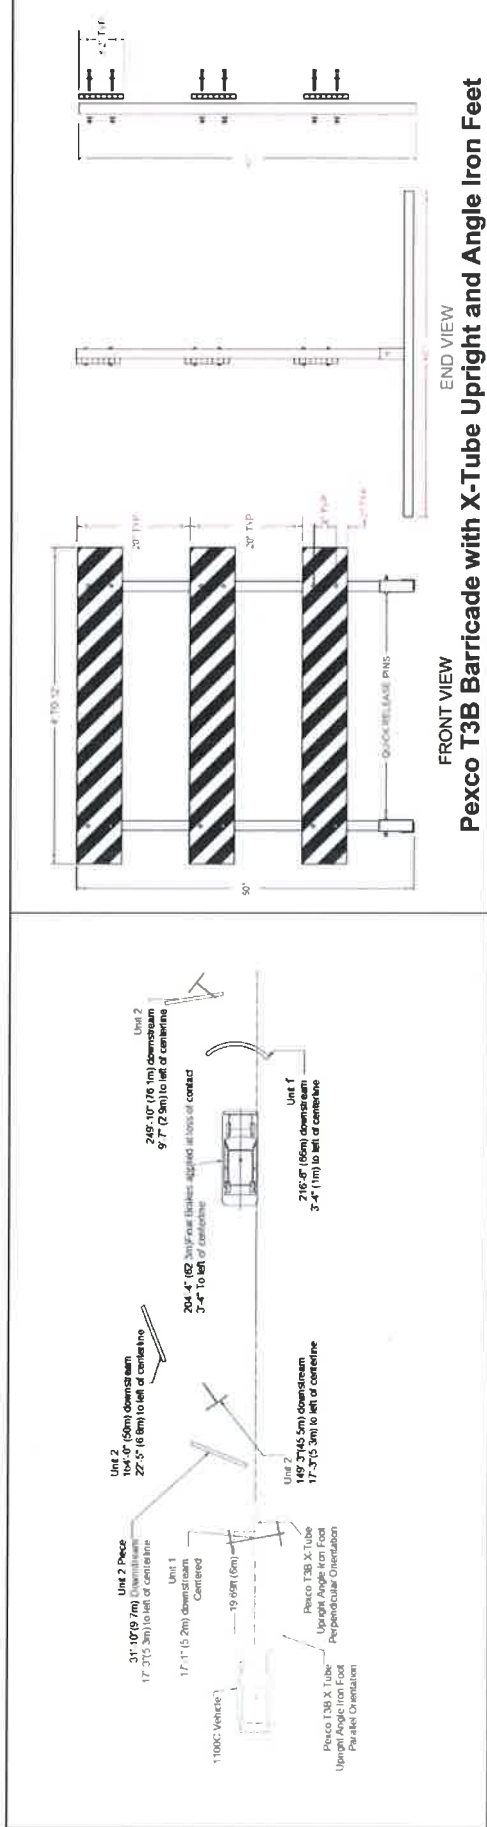
Pexco T3B Barricade with X-Tube Upright and Angle Iron Feet

t = 0.143 sec

t = 0.251 sec

General Information		Test Vehicle		Vehicle Damage	
Test Agency	E-TECH Testing Services	Type	Production Model	Exterior	
Test Designation	MASH Test 3-71	Designation	1100C	VDS	FC-0 (negligible)
Test No.	81-0461-001	Model	2012 Ford Fiesta Sedan	CDC	12FCLW0 (negligible)
Date	6/27/2017	Curb	1139.0 kg	chlorine Occupant Compartment Deformation	
Test Article		Test Inertial	1118.0 kg	Windshield	25 mm (max)
Type	Pexco	Dummy	N/A	All other areas	Negligible
	12 m wide T3B Barricade with X-Tube Upright and Angle Iron Feet	Gross Static	1118.0 kg		
Dimensions	1.52 m OA Height x 3.66 m Wide	Impact Conditions			
Installation Details	Three horizontal panels measuring 1.52 m, 1.02 m and 0.51 m high (Top of Panel to Grade)	Speed (Normal Orientation)	101.6 kph		
Material and Key and Elements	19.5 kg Complete, Steel Legs, RPVC Uprights and (3) 3.66 m wide HDPE Panels with Reflective Sheetting	Speed (Perpendicular Orientation)	100.1 kph

Foundation Type and Condition	Asphalt, clean and dry	Impact Severity (Normal Orientation)	445.6 kJ		
		Impact Severity (Perp. Orientation)	432.2 kJ		
		Exit Conditions			
		Speed (Normal Orientation)	100.1 kph		
		Speed (Perpendicular Orientation)	99.4 kph		
		Angle (deg)	0

For the 90 deg test article, the 1100C vehicle's front bumper first impacted the cantilevered lower HDPE panel of the test article. The lower panel was pushed forward then buckled as the uprights began to deform. The lower corner of the middle panel then contacted the test vehicle's hood and buckled as it slid up towards the windshield. The lower corner of the upper panel initially contacted the vehicle's windshield and cracked/deformed the windshield as the panel began to buckle. The entire test article remained forward of the windshield and continued to push forward. Pieces of the test article began to separate as the vehicle came to rest.

The test vehicle sustained negligible damage to the front bumper, hood and roof. As the ends of the barricade (0 deg orientation only) wrapped around the front end of the car, it contacted the driver mirror which partially detached. There was deformation on the windshield from direct contact from the HDPE panel with reflective sheeting (90

deg orientation only) which resulted in localized deformation, with 25 mm max. deformation. The damage to the test vehicle was categorized as FC-0 (negligible) on the Vehicle Damage Index and as 12FCLW0 (negligible) on the Collision Deformation Classification Scale along the principal direction of force. There was negligible deformation to the occupant compartment based upon pre and post-test measurements. The Vehicle Compartment Deformation Index (VCDI) was categorized as AS0000000 as there was no measurable or visual deformation of the occupant compartment.
